# Navajo Abandoned Uranium Mine

# **Site Screen Report**

# Martin Mine and George Simpson No. 1 AUM Site

Weston Solutions, Inc.

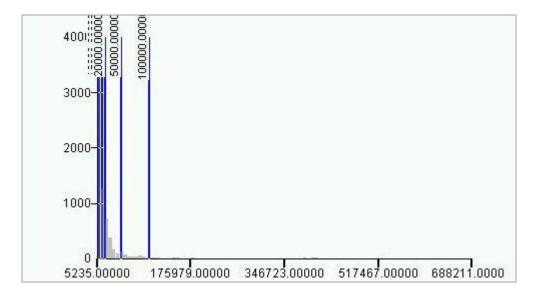
A total of 6,647 gamma radiation measurements were collected from the mine site, ranging from 5,235 cpm to 688,211 cpm. Measurements collected in the vicinity of the waste debris were found at levels ranging from approximately 50,000 cpm to 680,000 cpm, and near the adits at levels up to approximately 400,000 cpm. The measurements are represented in Figures 1 and 2.

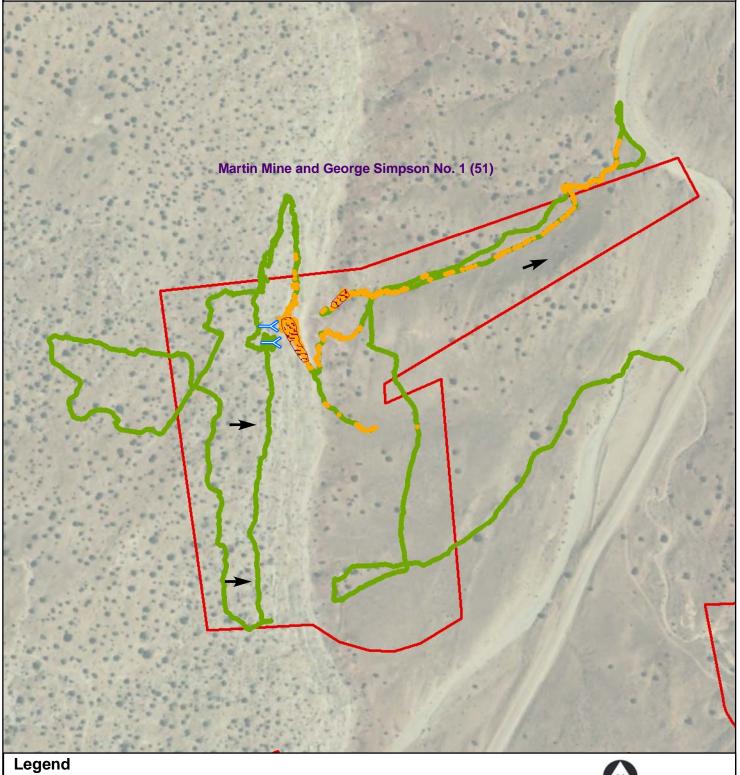
Figure 1 - Gamma Radiation Measurements, Above Two Times Background
Martin Mine and George Simpson No. 1 (51)
Sweetwater / Teec Nos Pos Chapters, Navajo Nation

Average background = 9,014 cpm

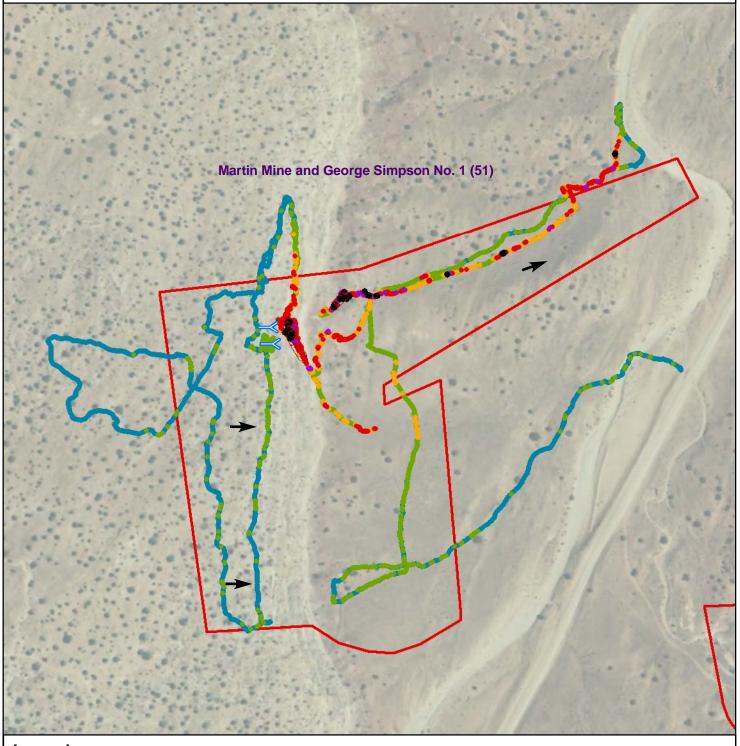
Figure 2 - Gamma Radiation Measurements Martin Mine and George Simpson No. 1 (51) Sweetwater / Teec Nos Pos Chapters, Navajo Nation

Average background 9,014 cpm
